RARITAN RIVER BASIN

DAVIDSON'S MILL POND DAM

PHASE I INSPECTION REPORT
NATIONAL DAM SAFETY PROGRAM

Name of Dam Davidsons Mill Pond Dam NJ 00516

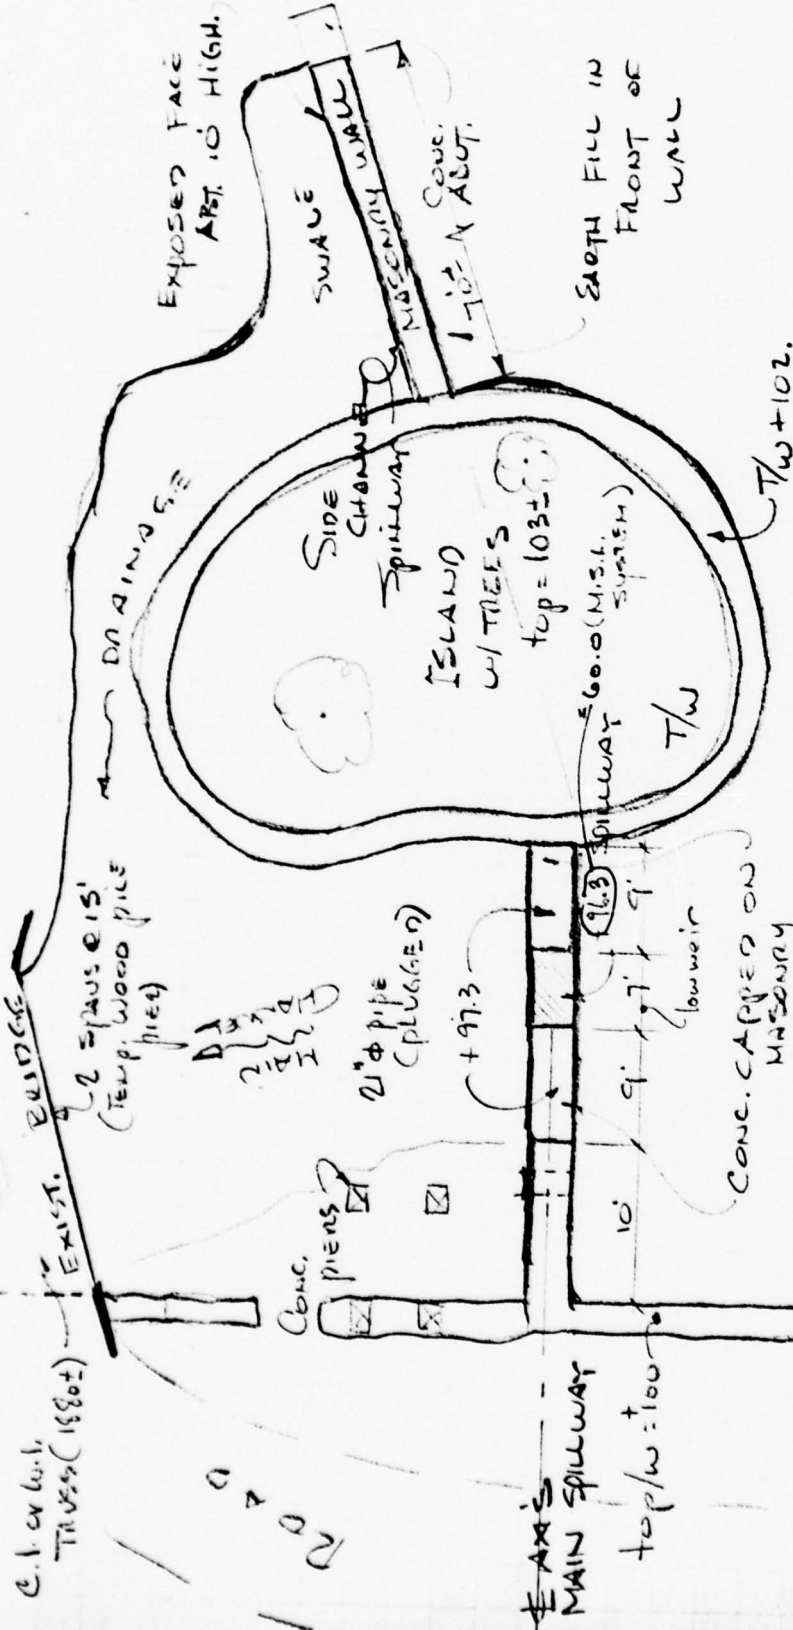
FIGURE 2

NOTE: ALL WALLS - APPROX. 2'
 RANDOM ASHLAR MASONRY.
 SOME JOINTS MORTARED.
 BAD CONDITION.

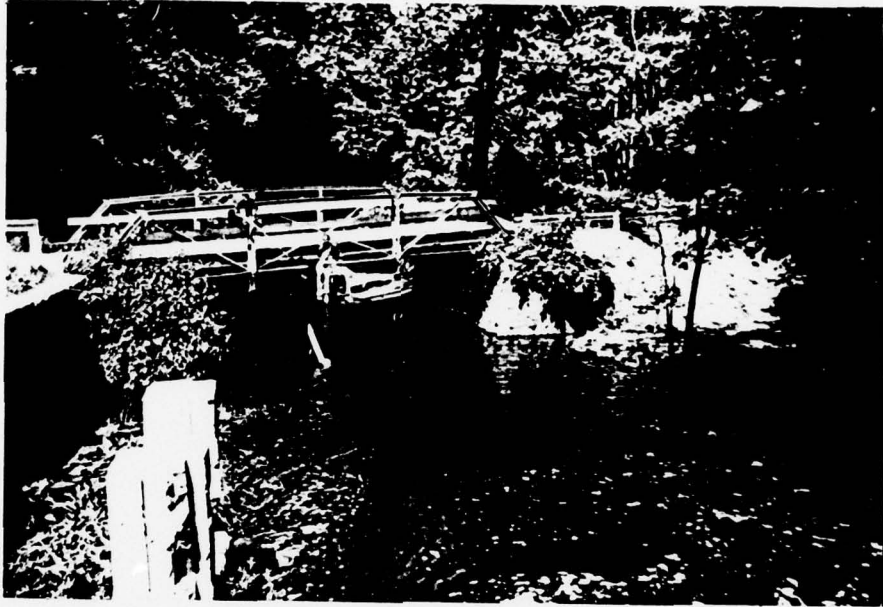
Downstream of Spillway
